MEMORANDUM FOR DCMA IRAQ

FROM: DCMAC-JSM, Mr. Paul W. Dickinson, [REDACTED] 1 February 2007

18 February 2007

SUBJECT: DCMA Iraq Safety Assessment

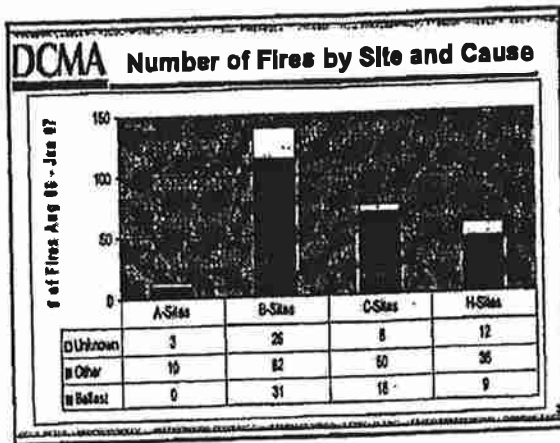
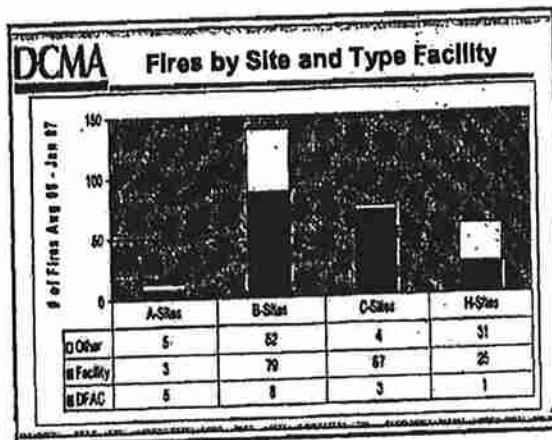
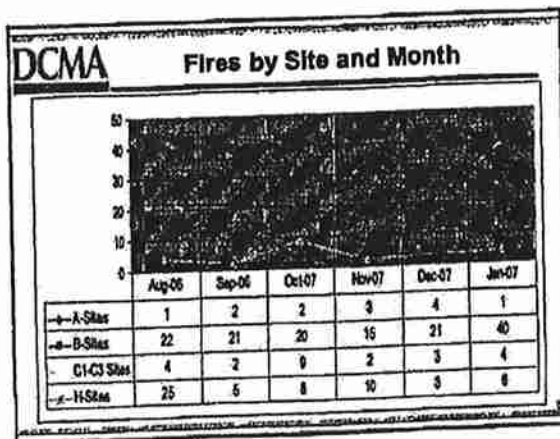
- I asked for data from the installation KBR safety/fire departments for August 06 - January 07.
- B-sites had the most fires at 139 (includes Al Asad and Fallujah); C-sites were next with 74; H-sites = 67; A-sites = 14
- Of the 17 DFAC fires reported through January, only 3 have undetermined/unknown causes. The rest were caused by electrical shorts or "failure to clean & maintain."
- Anaconda had no ballast fires, as they were the first camp to detect the overheat condition and install spacers.
- Overheating/faulty ballasts accounted for 22% and 23% of the fires at the B & C sites, respectively.
- While most of the facility fires were due to electrical shorts or overheating, there was no real trend. The cause of fires in some reports was just classified as "electrical."

- "Other" in the "Fire by Site and Type Facility" chart means a storage area, generator, vehicle, or grass fire.
- I did include vehicle fires in the total number, because some of them did have "human" causes.
- Sites C7-C8 did not provide the data by month, so I did not include them in the site-by-month chart.
- Al Asad did not provide reported fires for August, so I could only plot it for Sep-Jan in the site-by-month chart.
- Site data does not include the H-S DFAC fire on 5 Feb, or the DFAC (ilt-grill fire at Al Asad on 14 Feb. These fires are still under investigation. If you count the month of February (so far), we would have had 19 DFAC fires since August (almost 5 DFAC fires each month).
- The number of fires at the B-sites has gone down this month (so far).
